Project Name: Gold King Mine	Site Location: Silverton, San Juan County, Colorado	Project No. 0001/1408-01
--	---	------------------------------------

PHOTOGRAPH LOG

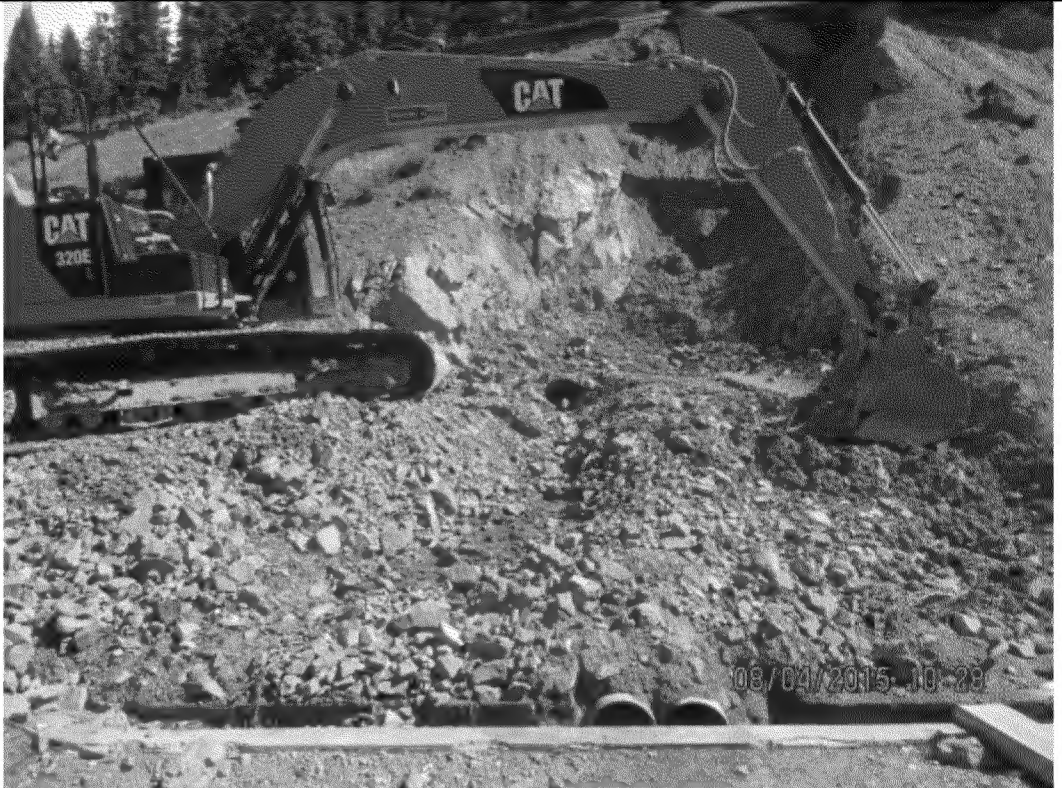
Photo No. 1	Date: 08/04/2015

Direction Photo Taken: North		
Description: Beginning investigation into collapsed adit.

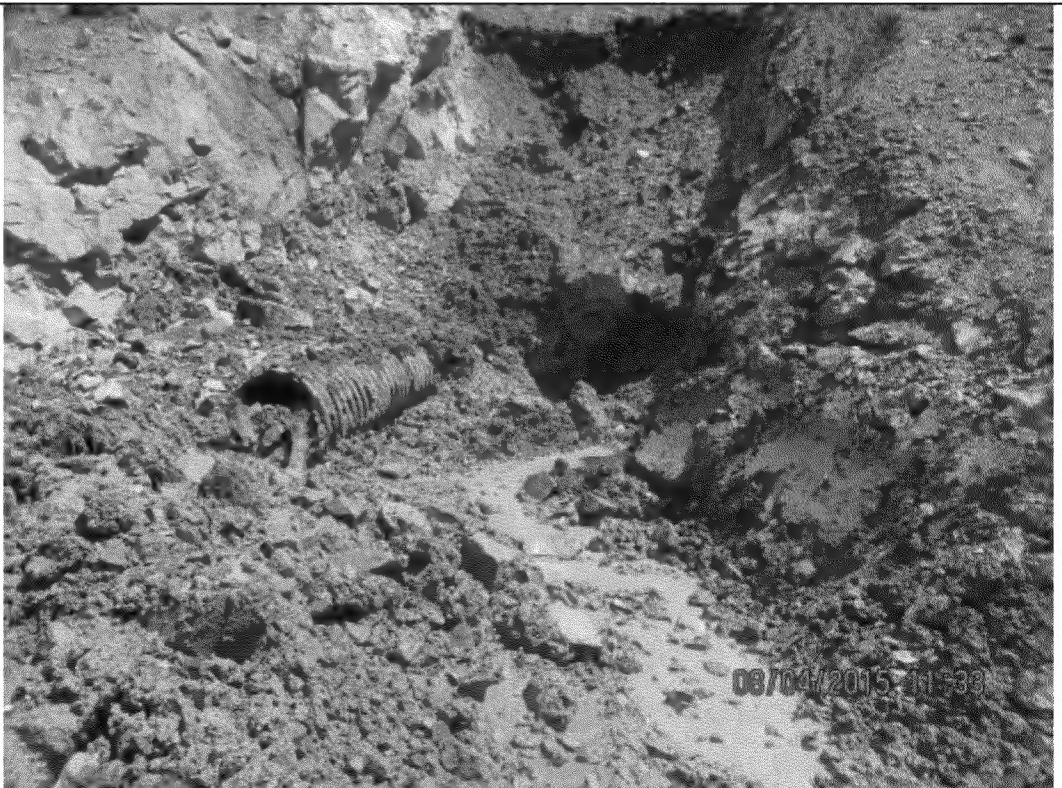
Photo No. 2	Date: 08/04/2015

Direction Photo Taken: North		
Description: Excavated next to DRMS-installed culvert, water muddy from soil disturbance.

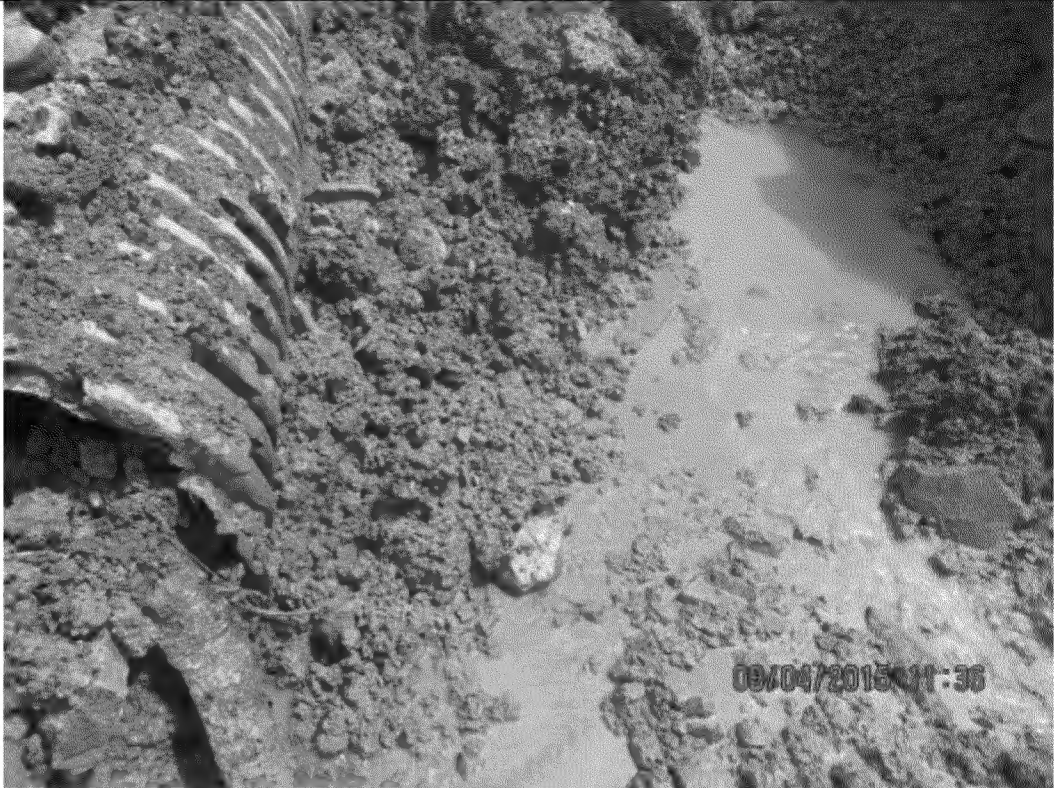
<p>Photo No. 3</p>	<p>Date: 08/04/2015</p>

<p>Direction Photo Taken:</p> <p>Down</p>		
<p>Description: Seepage from soil next to piping.</p>		
<p>Photo No. 4</p>	<p>Date: 08/04/2015</p>

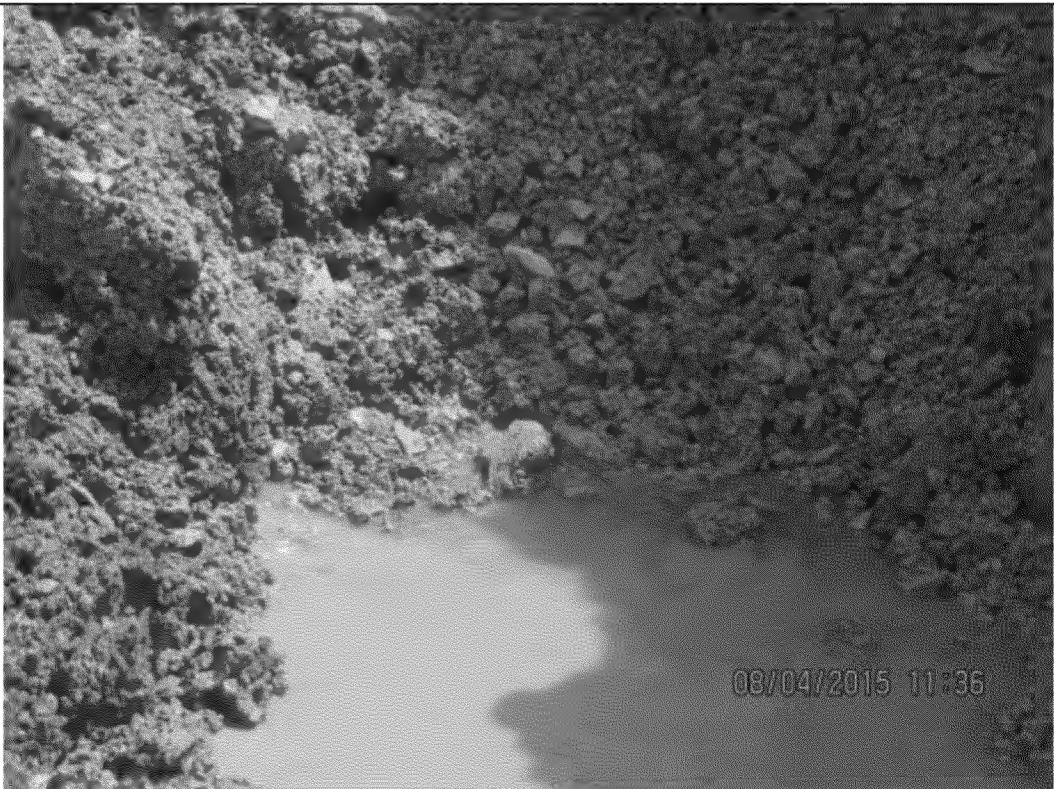
<p>Direction Photo Taken:</p> <p>Down</p>		
<p>Description: Seepage next to the pipe is clear until entering disturbed soil.</p>

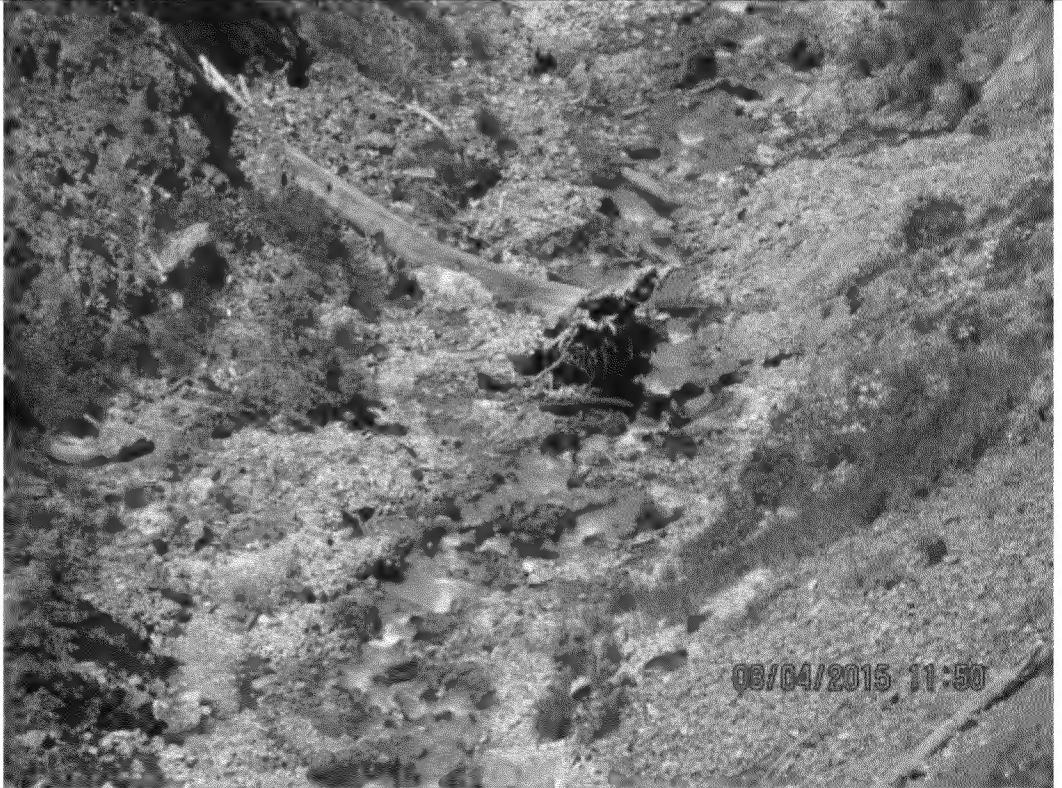
Direction Photo Taken: West		
Description: Water minimally murky from disturbed soil and water entering the North Fork from site.

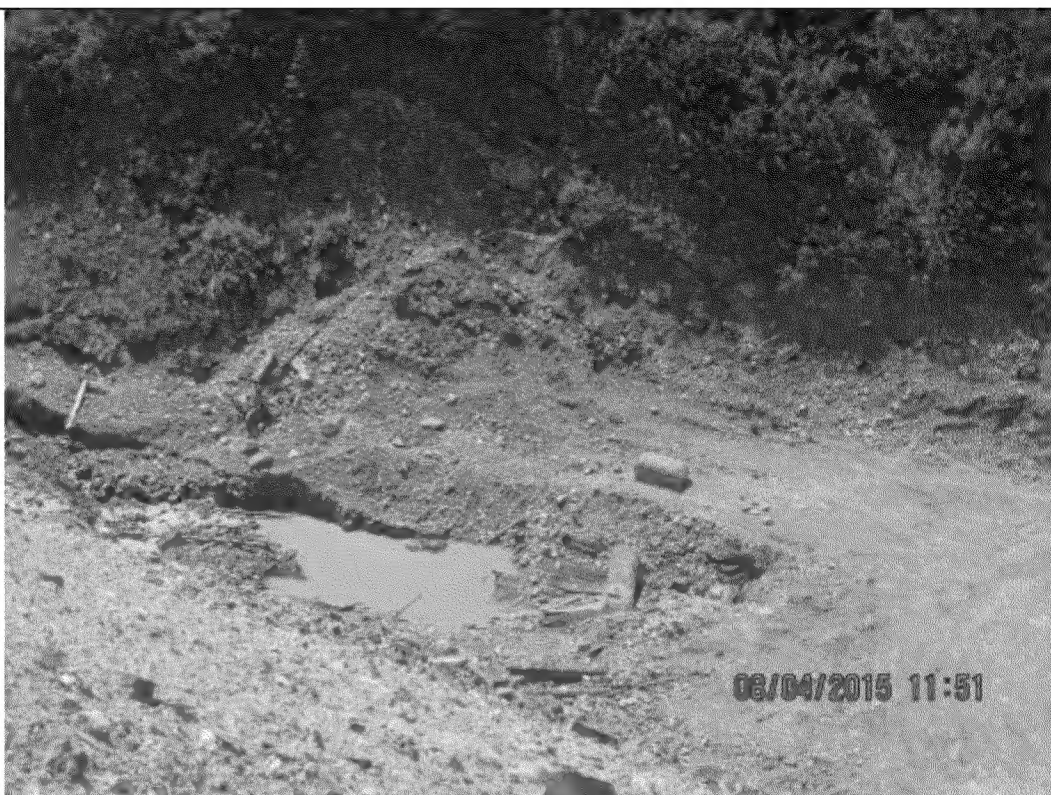
Photo No. 7	Date: 08/04/2015

Direction Photo Taken: South/Down		
Description: Hay bales installed as filter for sediment in North Fork.

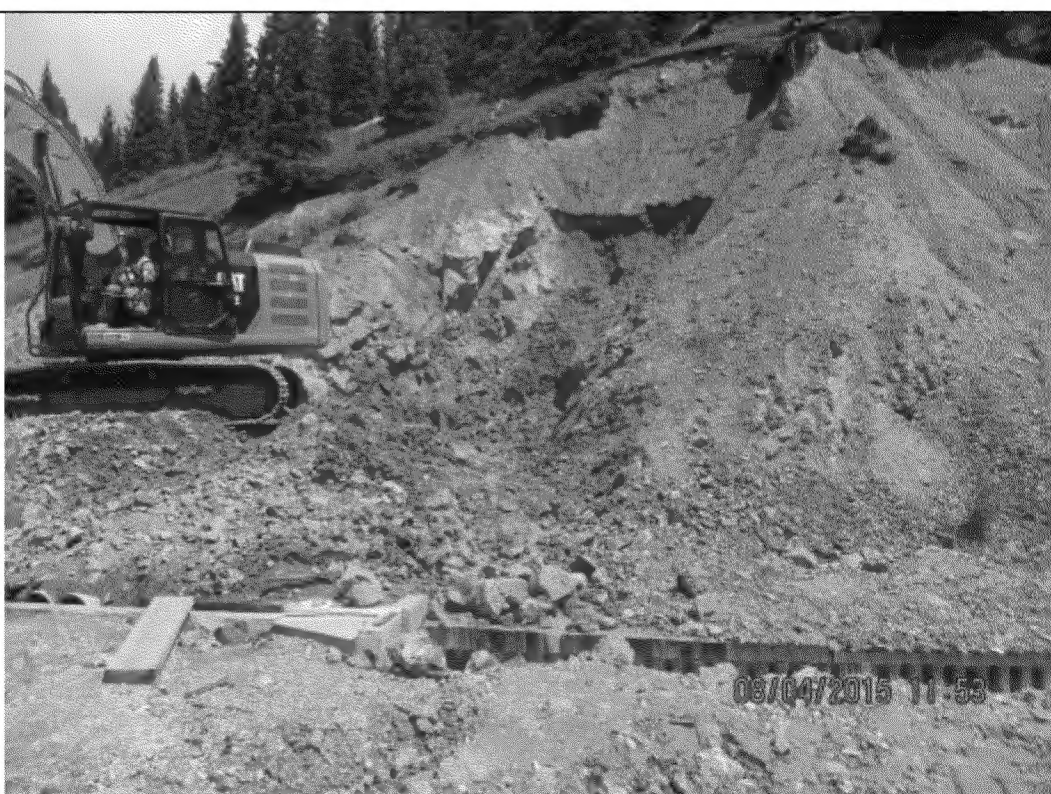
Photo No. 8	Date: 08/04/2015

Direction Photo Taken: Northwest		
Description: Continuing excavation at the collapsed adit, no solid bedrock found for tunnel support.

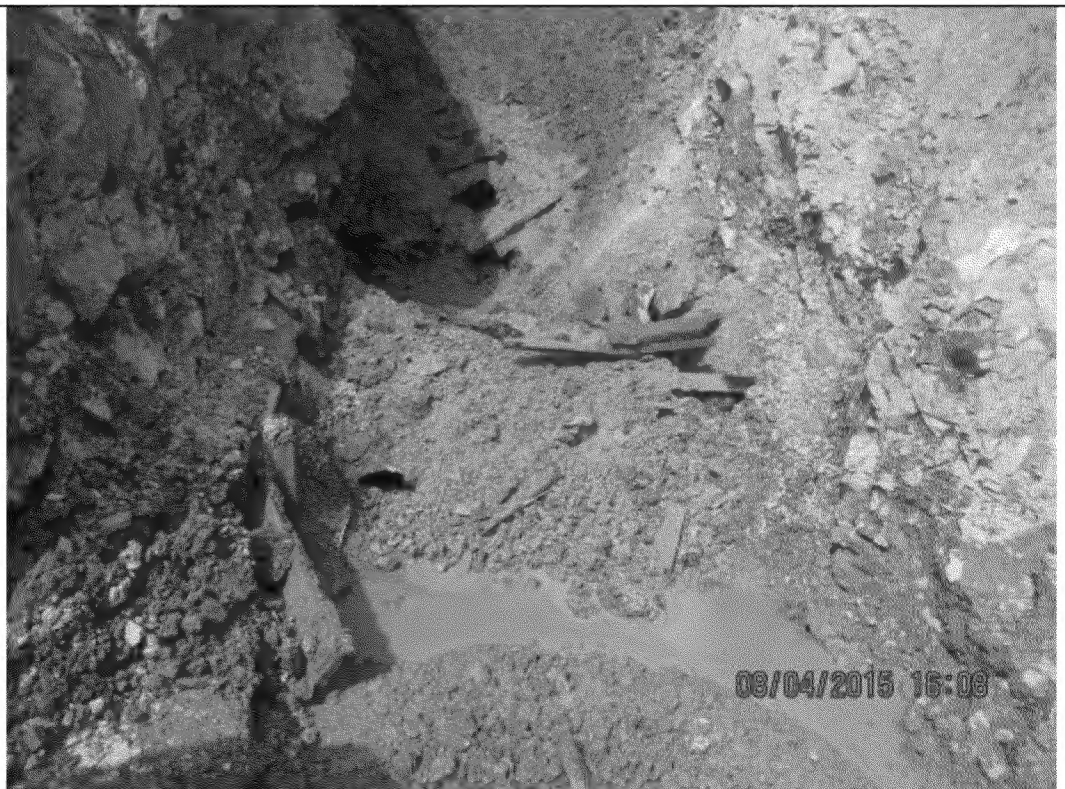
Photo No.

Collapsed supports uncovered above anticipated adit, no sign of bedrock above the adit area.

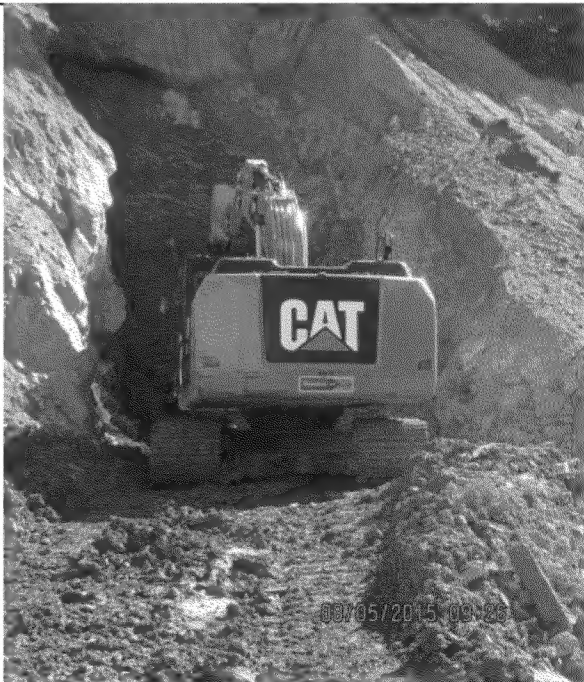
Direction Photo Taken: Northeast		
Description: Excavating material above the collapsed adit.

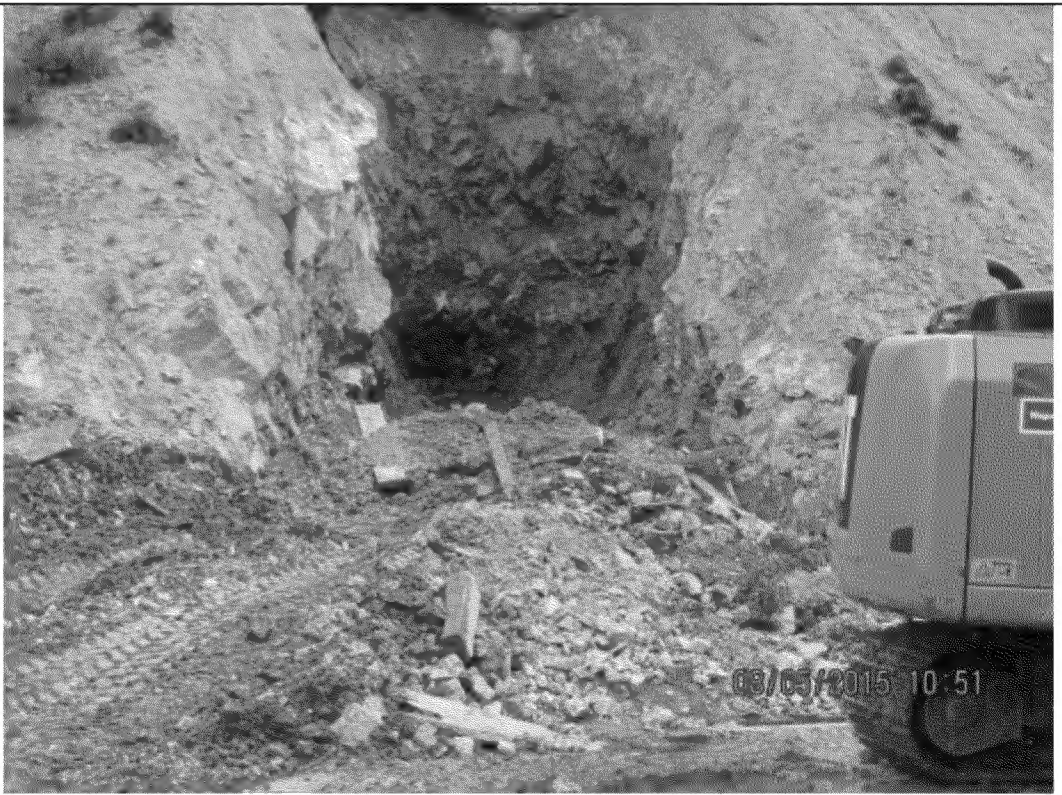
<p>Direction Photo Taken:</p> <p>North</p>		
<p>Description: Cleaning out excavated material, small leak.</p>

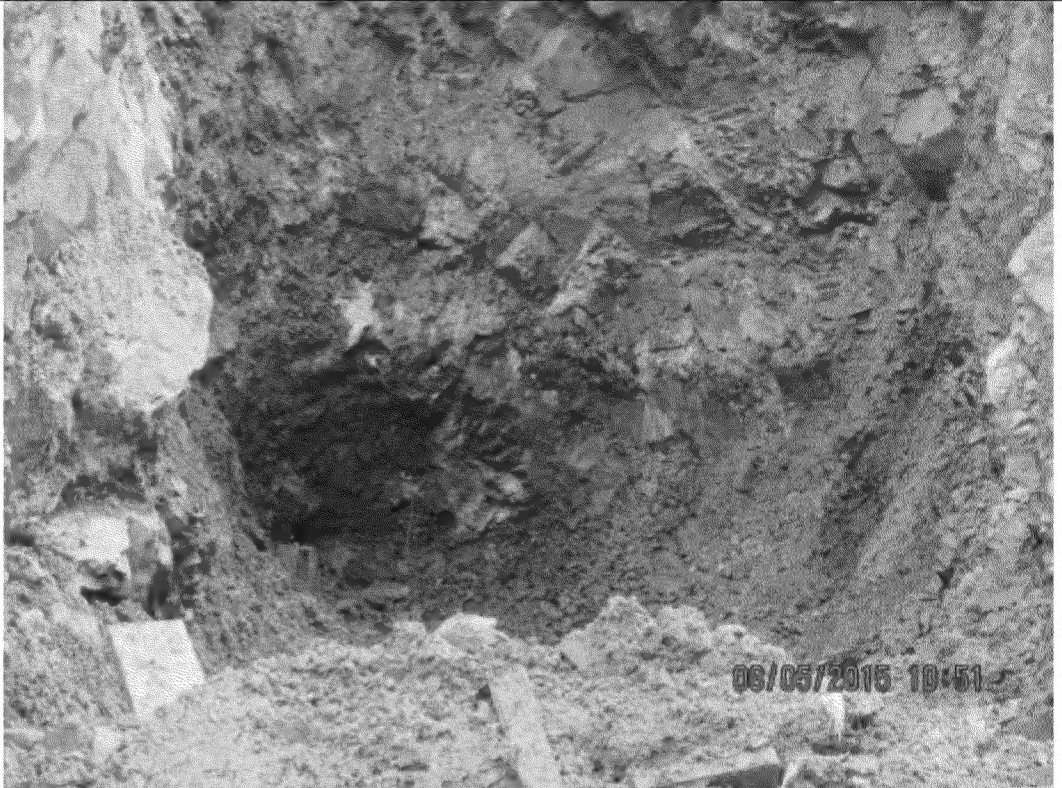
Photo No. 17	Date: 08/05/2015

Direction Photo Taken: North		
Description: Small leak close up.		
Photo No. 18	Date: 08/05/2015

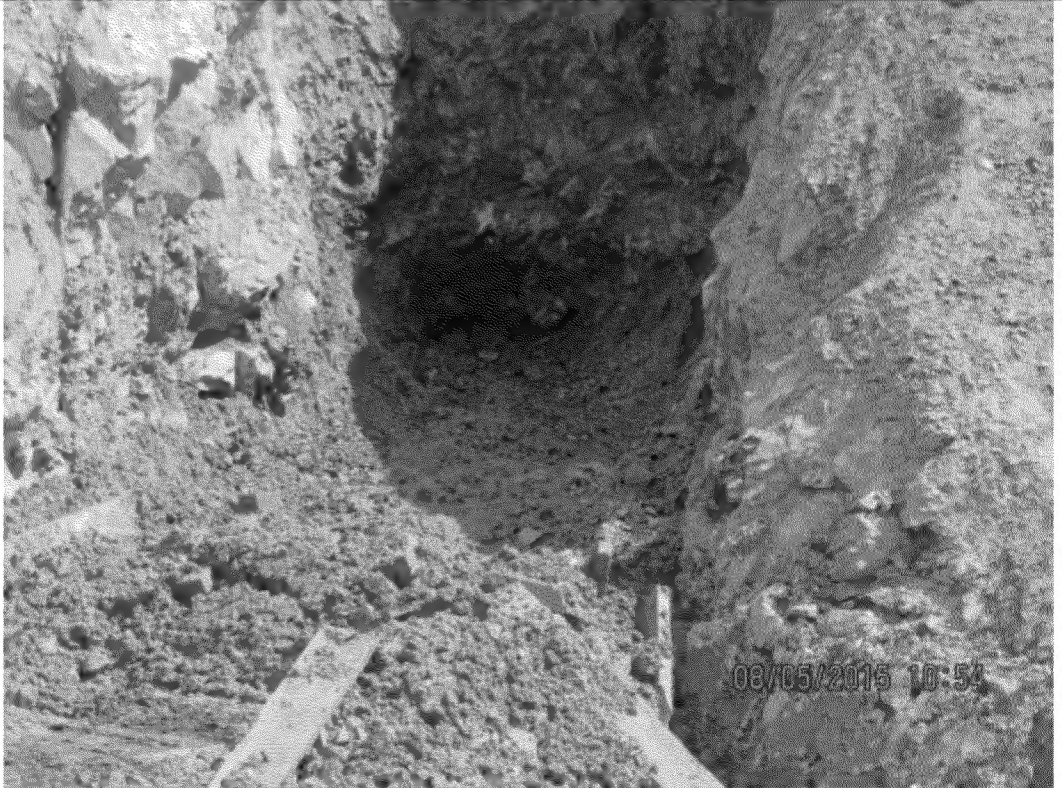
Direction Photo Taken: North		
Description: Hole starting to give way to flow.

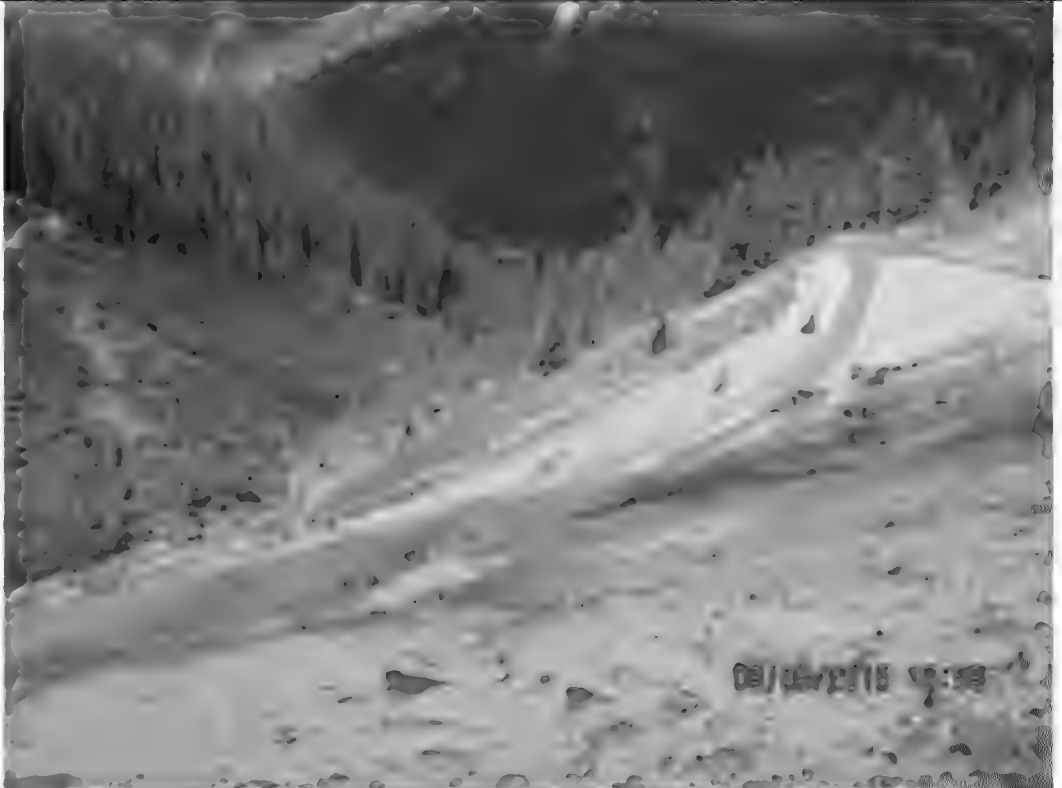
Photo No. 21	Date: 08/05/2015

Direction Photo Taken: West		
Description: Water flowing along access road and across waste dump		
Photo No. 22	Date: 08/05/2015

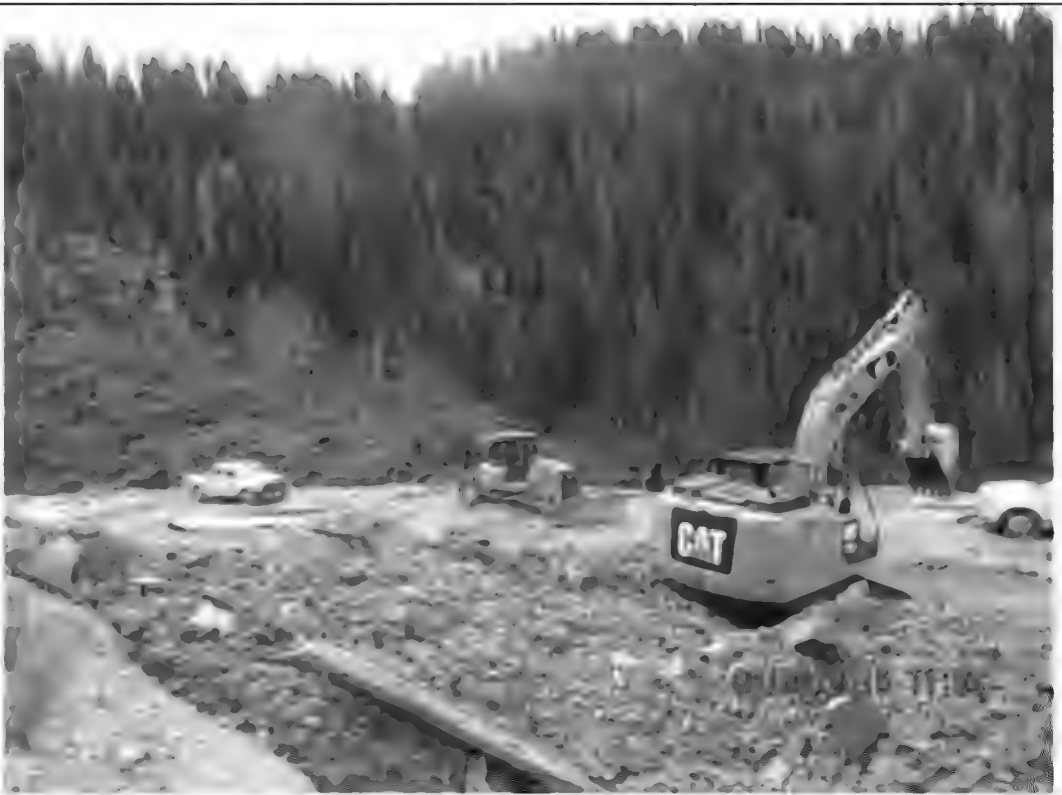
Direction Photo Taken: Southeast		
Description: Water flowing over the edge of the waste dump and collapsing the edge

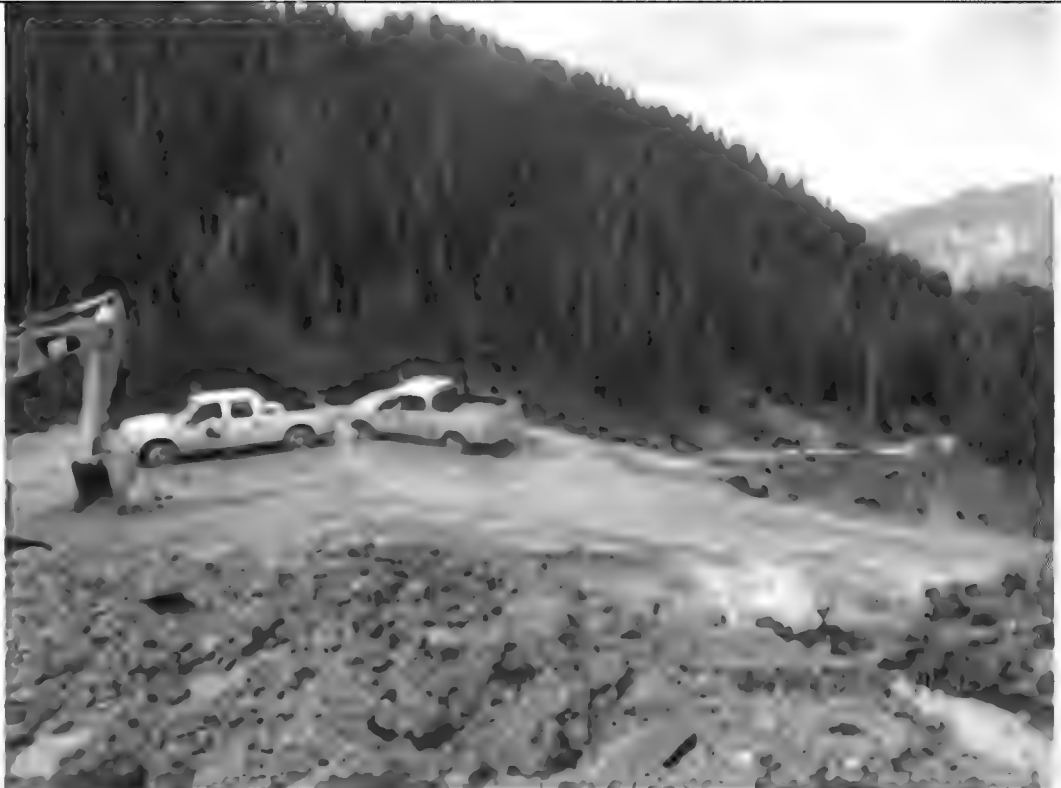
Photo No. 23	Date: 08/05/2015

Direction Photo Taken: Southwest		
Description: Exit route starting to collapse

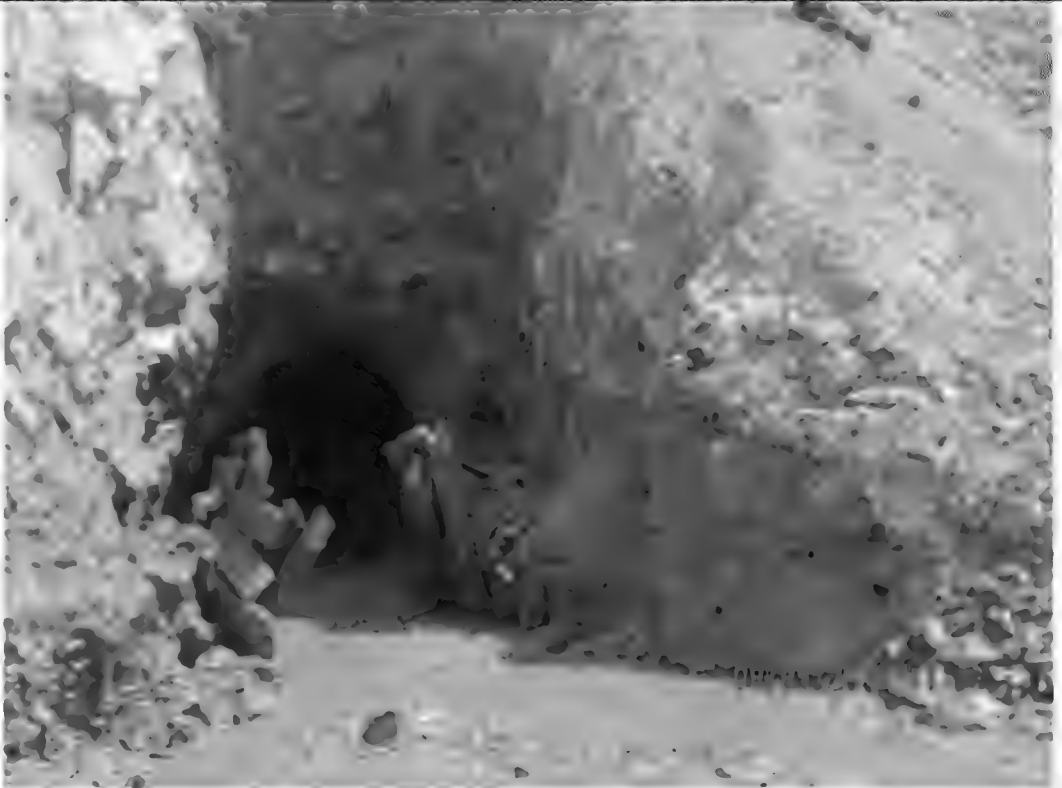
Photo No. 27	Date: 08/05/2015

Direction Photo Taken: North		
Description: Exposed adit, roughly 10 feet wide by 15 feet high.		
Photo No. 28	Date: 08/05/2015

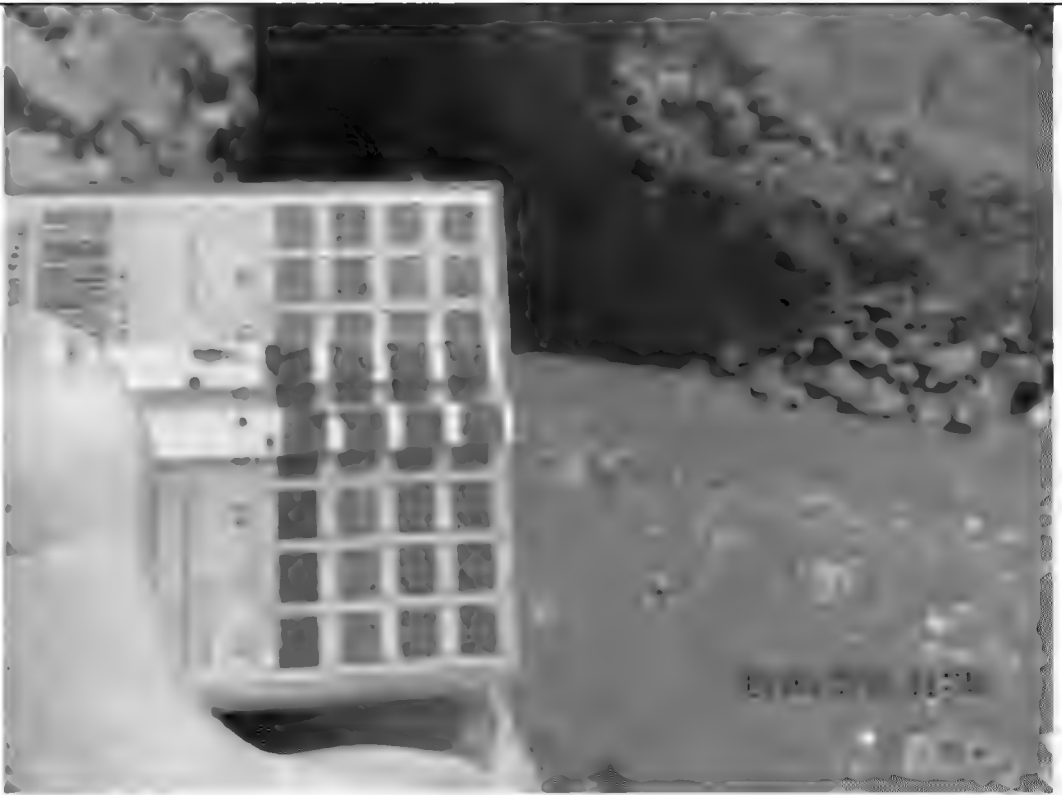
Direction Photo Taken: North		
Description: pH of discharge water is approximately 4 to 4.5.

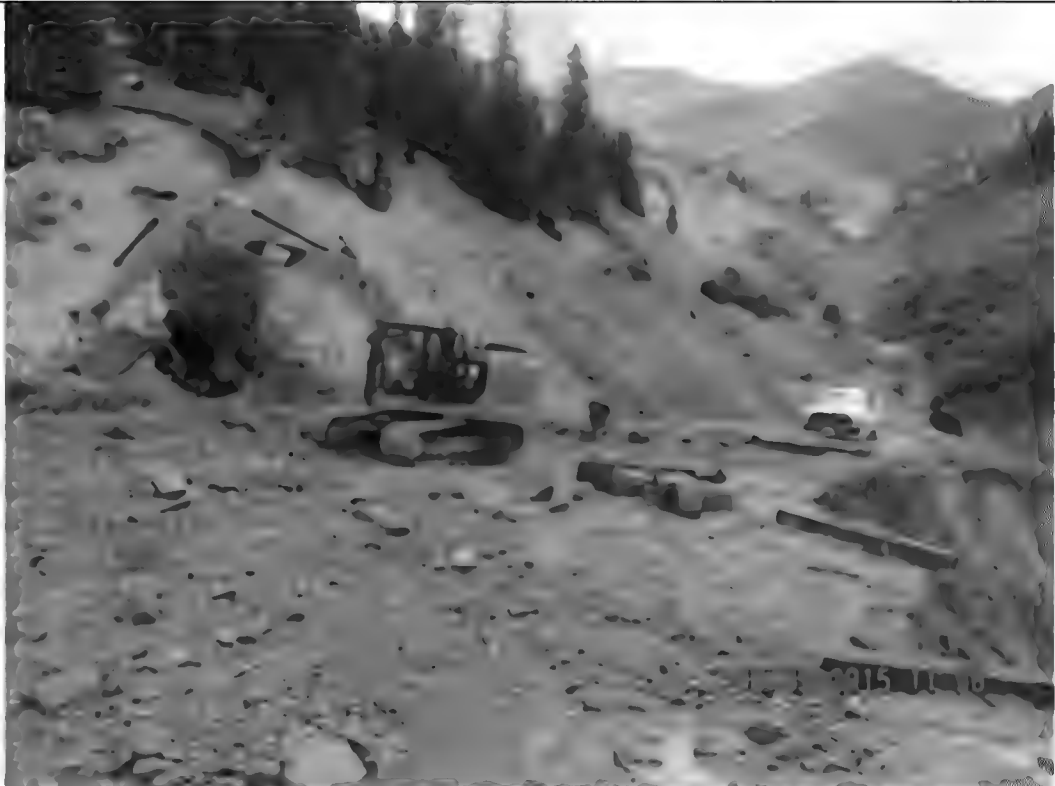
Photo No. 29	Date: 08/05/2015

Direction Photo Taken: Northeast		
Description: Excavator redirecting water into existing half-pipe channel

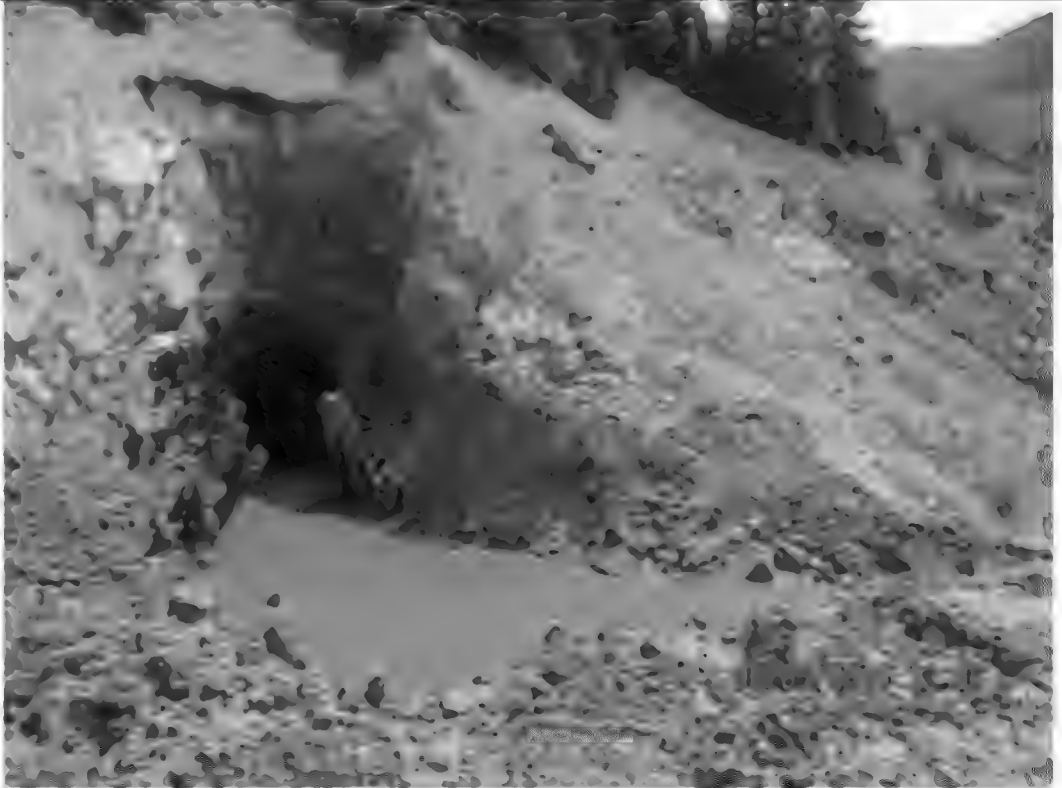
Direction Photo Taken: North		
Description: Exposed adit and redirected flow, flow is beginning to subside.

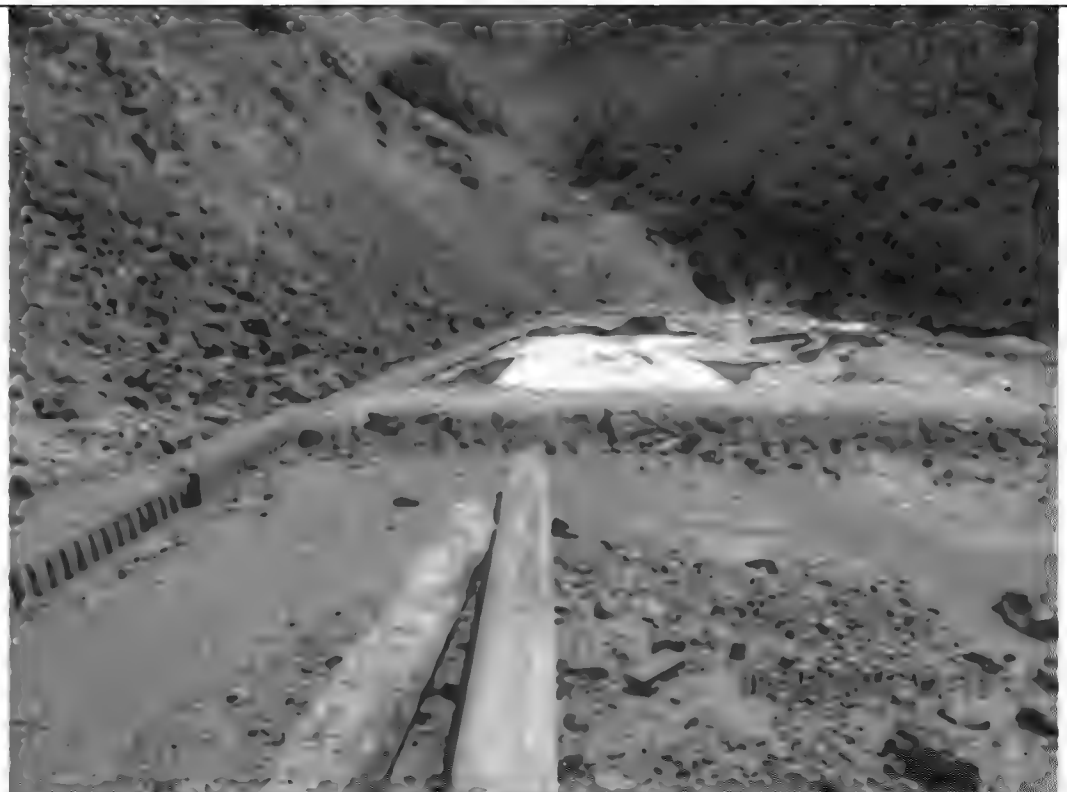
**Photo
No
36**

Existing flow channel at
maximum capacity

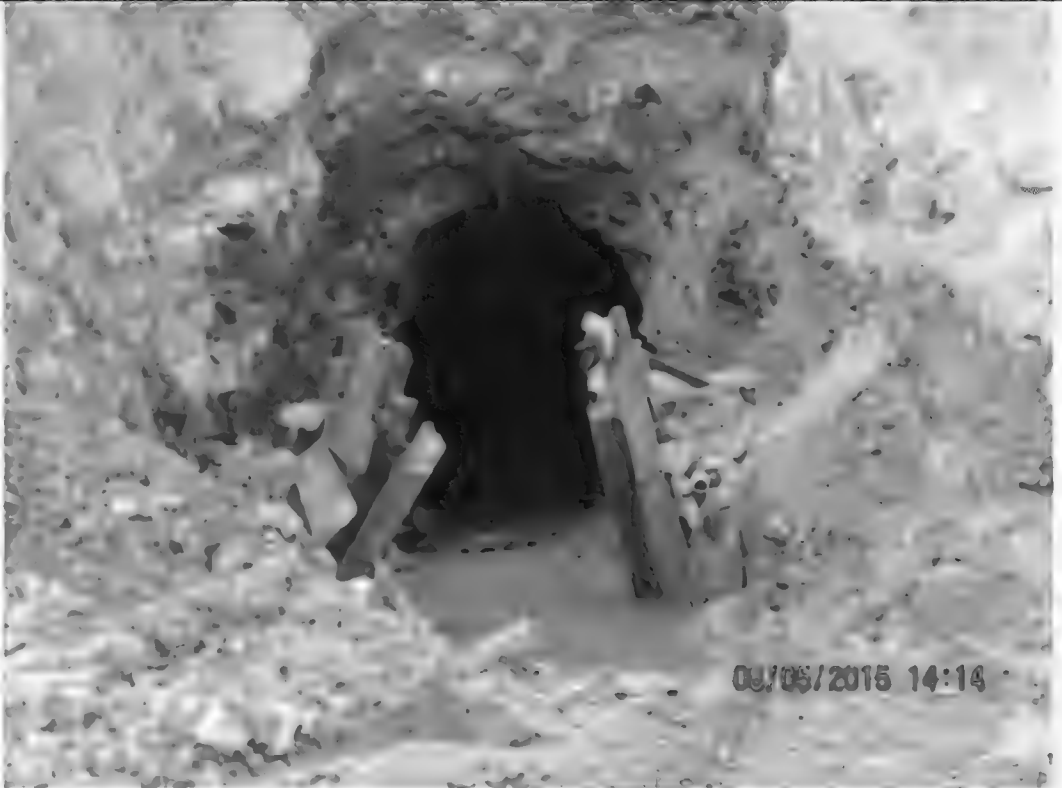
Photo No. 45	Date: 08/05/2015

Direction Photo Taken: North		
Description: Water levels lowering at adit entrance, no visible changes to structure.		
Photo No. 46	Date: 08/05/2015

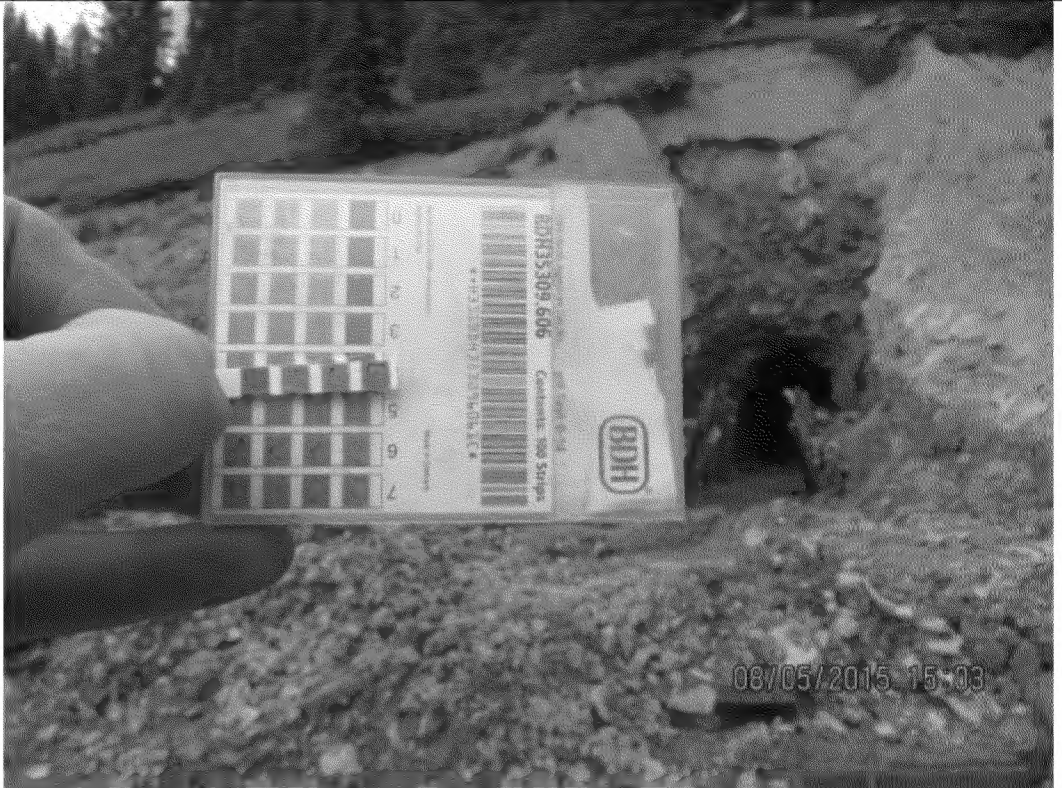
Photo No. 49	Date: 08/05/2015

Direction Photo Taken: North		
Description: pH measured at approximately 4.5.		
Photo No. 50	Date: 08/05/2015

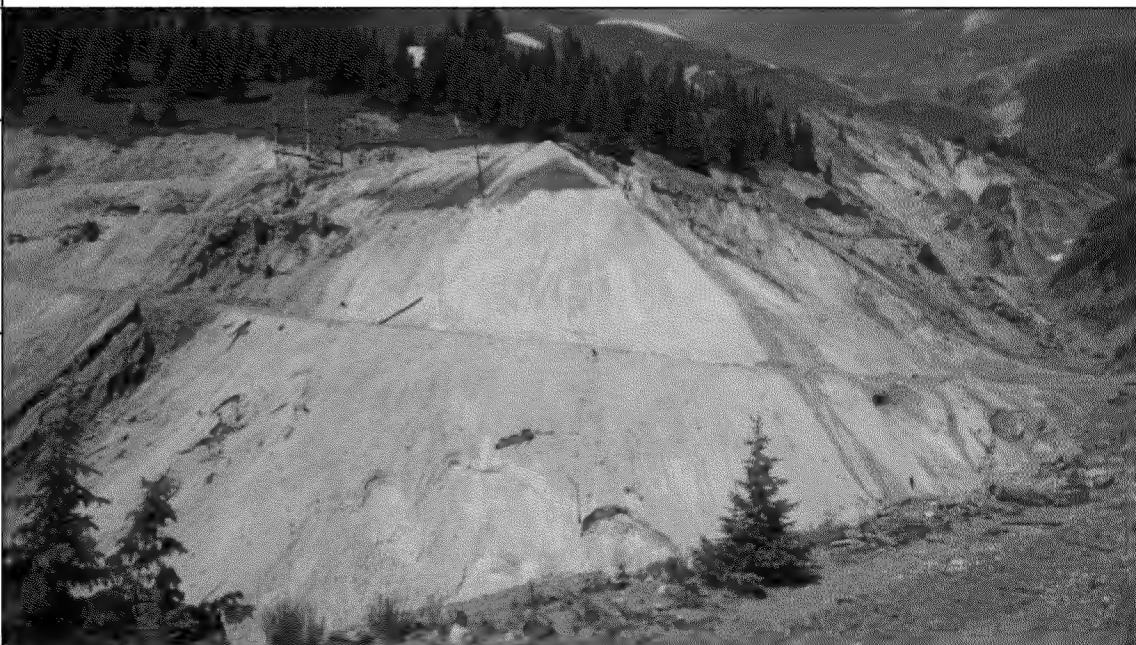
Direction Photo Taken: Northeast		
Description: Gold King Mine tailings dump after water discharge.
